# WJEC GCE AS/A level in BUILT ENVIRONMENT

## PATHWAY A EXEMPLAR

**Building Survey Report**

5 Priory Street

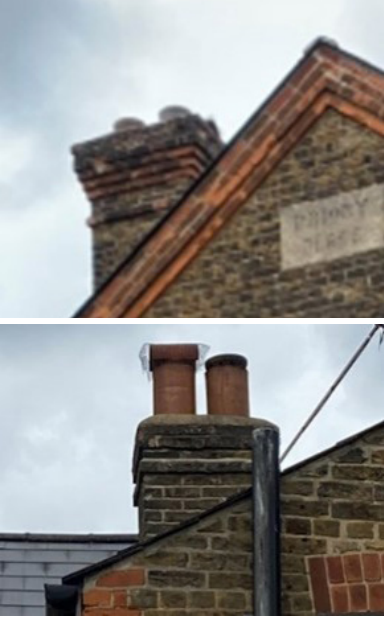
| D1: Chimney stacks | | 1 |
|---|---|---|
| | <p>Two brick chimney stacks projecting above the roof shape, one to the front of the property on a party wall and the other to the rear of the property. Both are constructed with brick with a lead flashing at the connection with the roof tiles.</p> | |
| | <p>No significant defects were evident but routine maintenance and repointing should be carried out in the future, as necessary.</p> | |

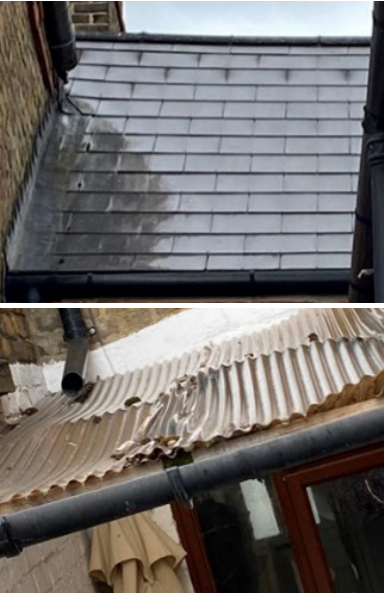
| D1: Chimney stacks | | 1 |
|---|---|---|
| | <p>The main roof comprises of a timber-framed, sloping roof with ridge lines running both perpendicular and parallel to the front of the property and a rear ridge running perpendicular to the back of the property.</p> | |
| | <p>The roof coverings for the main roof were inspected, as far as possible, from ground level and appear to be in good condition with no significant defects. Regular inspections and maintenance are recommended.</p> <p>There is a rear-covered area that is comprised of a polymer-based roof covering that is showing signs of failure. This type of roofing has a limited lifespan and is shown to be warping. It is recommended that this be updated and replaced within the next three years.</p> | |

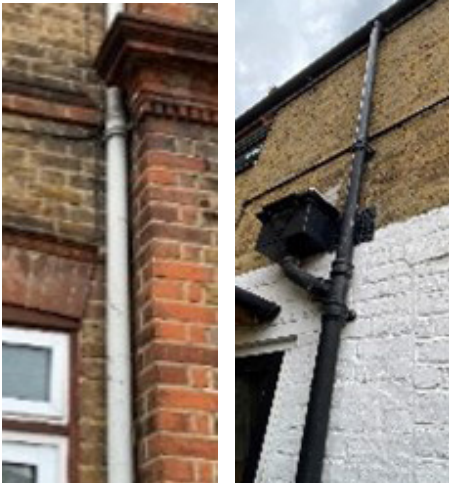
**D3: Rainwater pipes and gutters****2**

The roof valleys at the front of the property discharge into PVC gutters and hoppers with the rear rainwater drainage discharging into the soil pipe at the rear of the property.

The sewage system within the area is a combined system which means that rainwater and wastewater can be combined, however it is recommended that rainwater be discharged separately through a soakaway for sustainability purposes.

It is also recommended that pipes are regularly inspected and cleaned to prevent blockages.

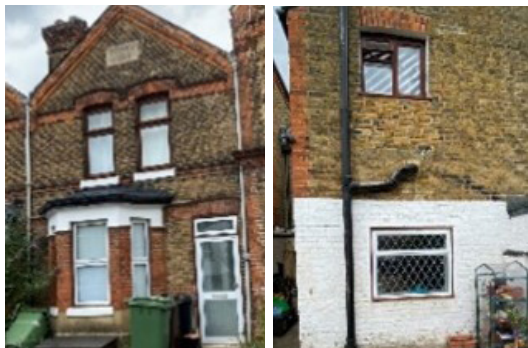
**D4: Main walls****1**

The main walls are of solid brick construction with an overall thickness of approximately 325mm. The rear elevation has painted bricks at ground level. There was no evidence of cracking or other signs of structural movement affecting the property and the main structure is therefore considered to be structurally sound.

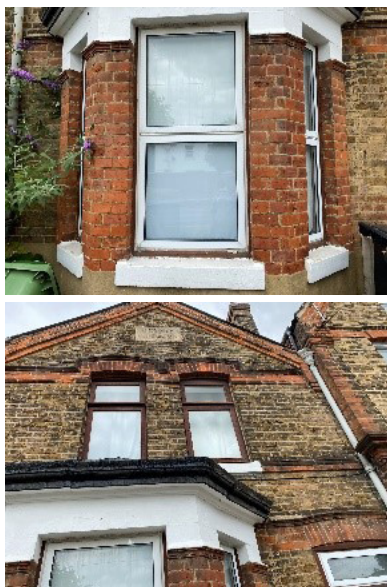
**D5: Windows****2**

The windows are a mix of aluminium and timber-framed with single glazing throughout the property. The windows throughout are in poor condition and have evidence of condensation and air leakage at multiple points.

It is recommended that windows are replaced throughout the property to ensure adequate energy efficiency and ventilation requirements.

Adequate ventilation is provided throughout the property. It is recommended that the windows are replaced with double glazed units, which will prevent heat loss. These should have adequate background ventilation as well as providing the rapid ventilation in accordance with the current building regulations Part L1A.

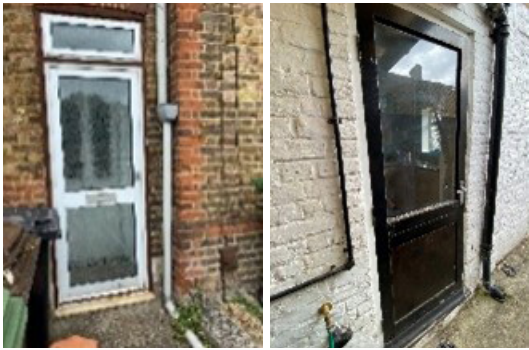
| | <p>The external front door is an aluminium frame with two large, glazed panels. The door is in adequate condition, however the age and material is not energy efficient and signs of air leakage are evidenced. It is recommended that this door is replaced with an energy efficient and high secure door for the front of the property.</p> | |
| | <p>The rear door is timber with a large, glazed panel. It is recommended that this door is also replaced.</p> | |

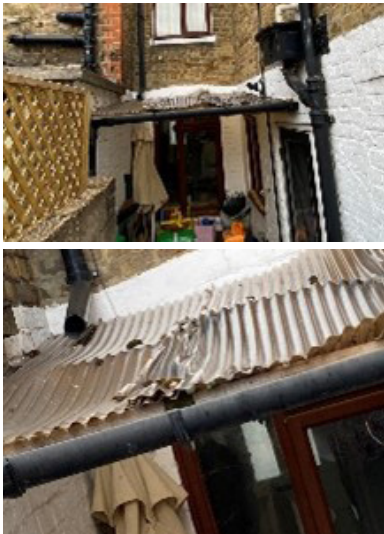
| | <p>A small covered area is present at the rear of the property. As previously stated, the roof area to this is in poor condition and it is recommended that this be replaced.</p> | |
| | <p>The porch at the front of the property is in adequate condition.</p> | |

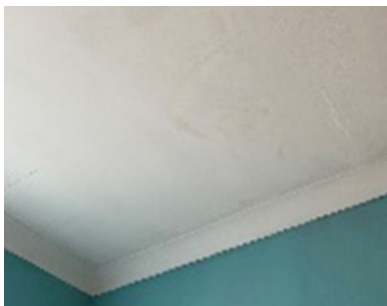
| E1: Roof structure | | NI |
|---|---|---|
| | <p>The ceilings are of plasterboard construction, with a smooth plastered finish and some coving to the edges throughout property.</p> <p>Some signs of damp shown under the bathroom area in the kitchen. Occupier has stated this is from a prior leak that has been fixed.</p> <p>It is recommended that the ceiling in the kitchen is inspected to ensure no damp issues with timber and that redecoration occurs.</p> | |

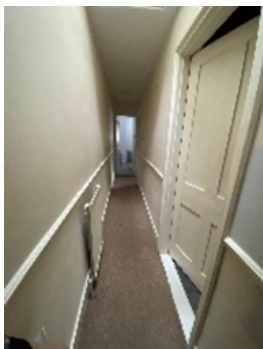
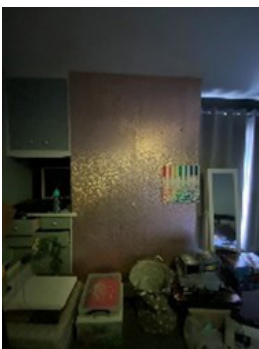
| E1: Roof structure | | NI |
|---|---|---|
| | <p>Internal walls are of solid construction, with smooth plastered finishes which have been decorated. Some walls have rails.</p> <p>An appropriate redecoration schedule is recommended.</p> | |

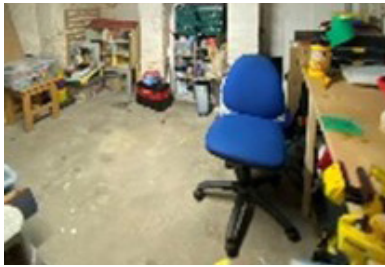
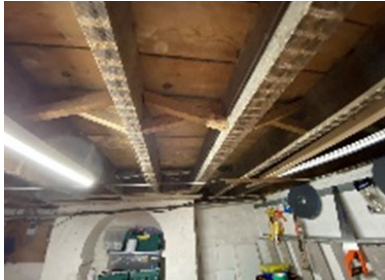
**E4: Floors****1**

The basement floor is a solid concrete with no obvious defects.

The ground floor is a suspended timber floor, as shown in the images.

The first floor is suspended timber construction.

All floors have fitted survey coverings, so this limits the inspection, however no obvious defect was evidenced.

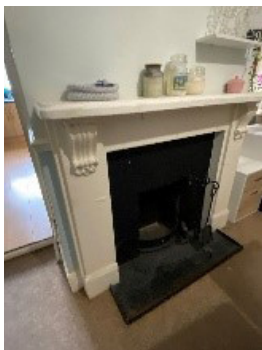
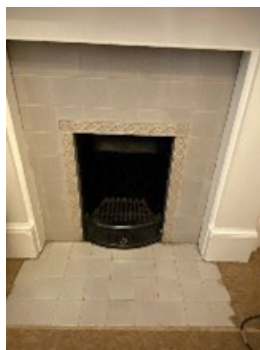
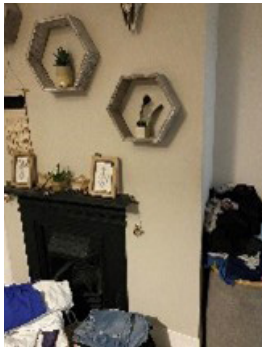
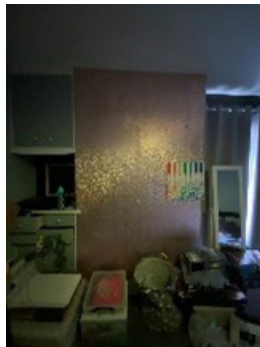
**E5: Fireplaces, chimney breasts and flues****1**

There are three fireplaces in the house, plus one boarded fireplace.

All three fireplaces are not in use and are decorative in nature; they are in the living room, the main bedroom, and the dining area.

The boarded fireplace in bedroom two is ventilated appropriately.

It is recommended, should the occupier wish to use the fireplace, that they are inspected prior to use.

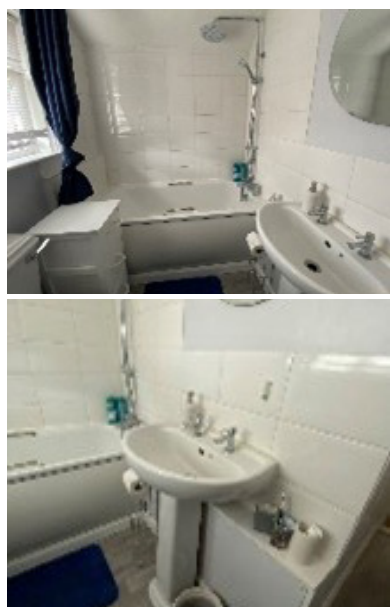
## E8: Bathroom fittings

The bathroom is fitted with a white suite comprising of a WC, sink and bath, with mixer tap and overhead shower. The sanitary fittings appear to be in adequate condition.

It is recommended that regular inspection of seals around the fittings is undertaken to ensure that leaks are prevented and that plumbing systems are regularly maintained to keep everything in good working condition.

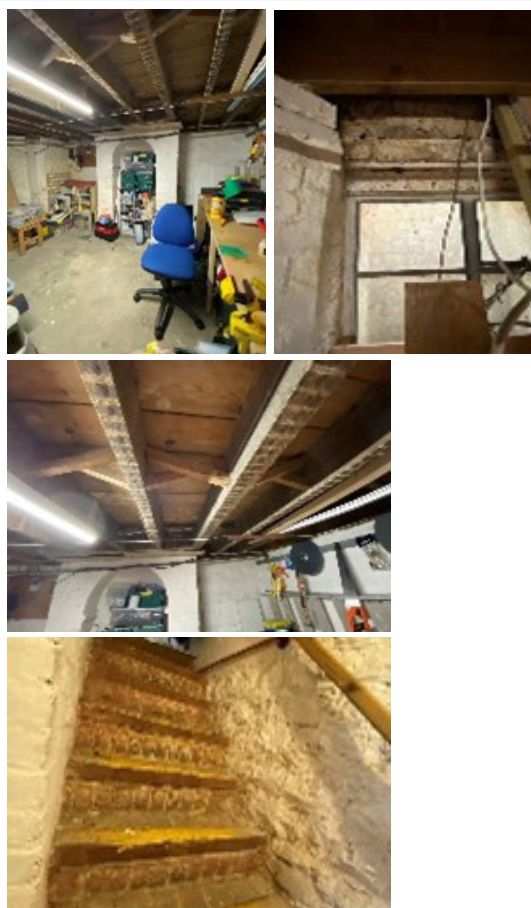
## E9: Other

| Element No. | Element name | Comment |
|---|---|---|
| E9 | Other – basement walls | Further investigative work to use a moisture meter to check damp levels in the basement walls and the kitchen walls where the exterior has been painted. This will help determine if there could be a potential with rising damp or moisture penetration. |

The property has a basement that is currently used for storage. There is a strong damp smell, indicating that moisture is getting into the property. The occupier has stated there was a leak from a broken pipe on a neighbouring property approximately a year ago, which caused the basement to flood.

E9 – Other: Damp issues in the basement need to be inspected to prevent damp spreading from walls and into timber, which is prone to rot.

It is recommended that a full damp survey is conducted with moisture levels in the walls measured to ascertain the extent of the issues. Further recommendations from this survey will consist of methods to prevent moisture ingress and use of a dehumidifier to assist with moisture in the property.

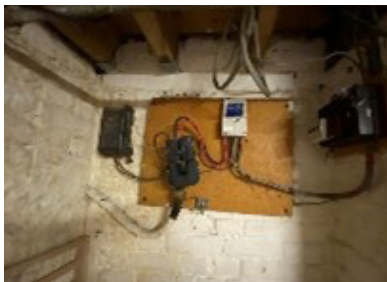
| F1: Electricity | | 2 |
|---|---|---|
| | <p>The mains electricity is connected to the property and the electricity meter and consumer unit are in the basement.</p> | <p>It is recommended that a qualified electrician conducts an electrical survey of the property to ascertain any risks associated with the electricity system throughout.</p> |

F1 – Fire risk: The electrical installation should be tested and updated to ensure that there is no risk of damage to the building.

F1 – Electricity: The electrical installation should be tested and updated to ensure that there is no risk of injury.

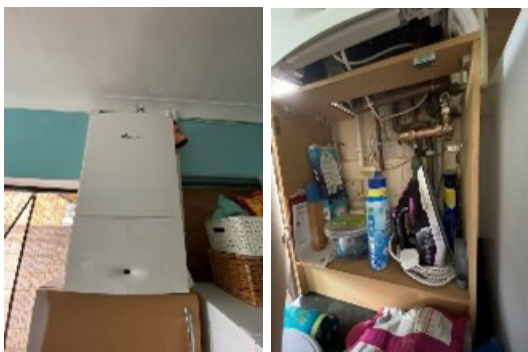
| F1: Electricity | | 2 |
|---|---|---|
| | <p>There is a small combination boiler in the kitchen, which provides both the heating and hot water for the property. The service label on the boiler shows that it has had a recent inspection and test conducted.</p> | |

| F1: Electricity | | 2 |
|---|---|---|
| | <p>It is recommended that maintenance and inspection is carried out as per manufacturers guidelines and safety tests are conducted at least annually.</p> | |

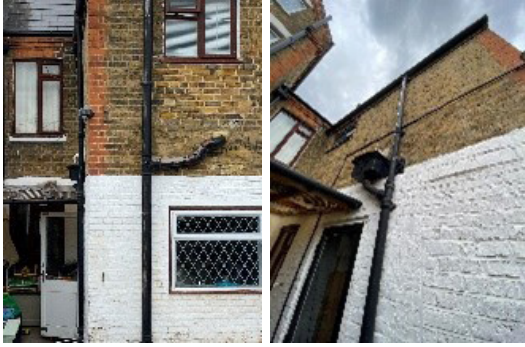
**F6: Drainage****1**

There are two soil and vent pipes at the rear of the property, one taking the bathroom sink and bath waste (side elevation) and the other taking the toilet and kitchen waste (rear elevation). Pipes appear in adequate condition.

No underground inspections have been conducted or physical testing of drainage adequacy. It is recommended that these get checked on a regular basis via a maintenance schedule.

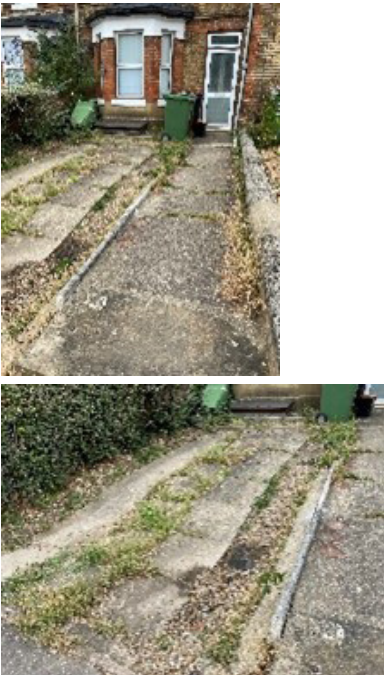
| | | <p>The property has a driveway at the front, which is accessible via Priory Street. The drive is uneven, and the paving slabs move under the weight of vehicles. There is currently no drop curb.</p> <p>It is recommended that a drop curb and a stable driveway is installed.</p> |
